# BUILDING SURVEY REPORT

SURVEY DATE 23 Jan 2018

The format of this MiBuilding Survey Report is consistent with the guidance note requirements for a Survey Level 3 as defined by RICS Surveys of Residential Property 3rd edition May 2016

### Etna Road, St. Albans

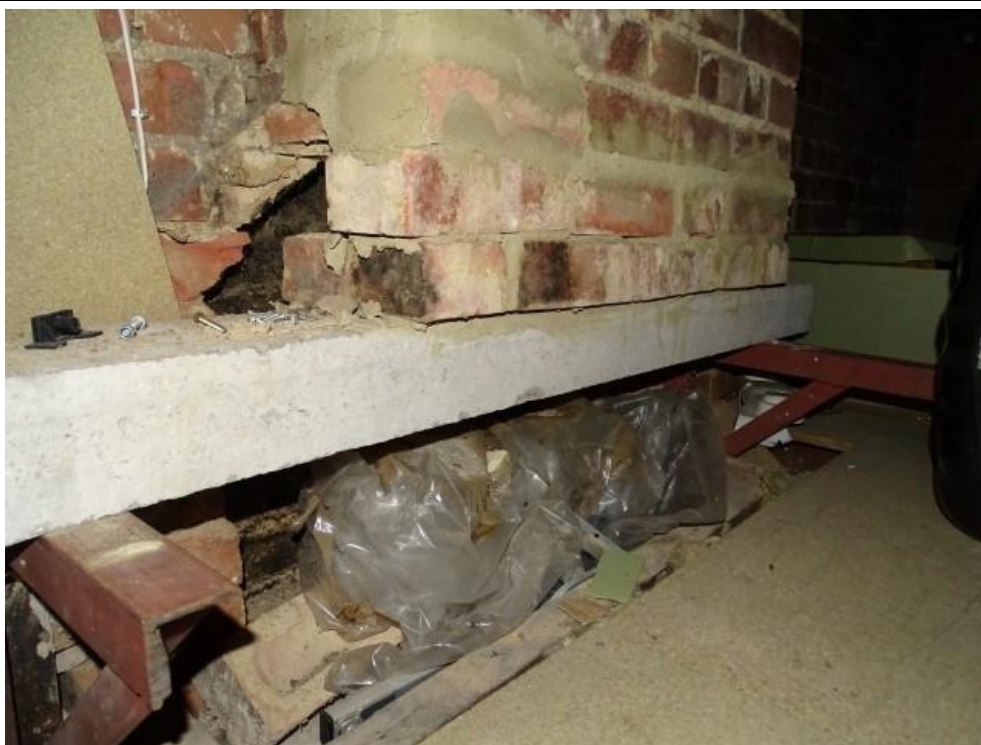
<b>Condition</b>	<p>All flashings, brickwork and pointing seen were in a fair condition.</p> <p>The pots are mostly uncapped and open to the elements. If any potsis left uncapped then rain can penetrate the flues and damp can appear inside the property on the breasts. Providing fireplaces are regularly used then any penetrating moisture will dry out, however if fireplaces are used infrequently then it would be prudent to provide rain cowls to allow flue gases to escape but prevent moisture ingress to the flue.</p>		
<b>Action Required</b>	<p>Some capping of the pots is required to prevent water penetration to the flues</p> <p>The chimney stack should be regularly monitored for any indications of damage, instability or other defects. Missing, loose or defective mortar should be re-pointed as necessary.</p>		
<b>Additional Information</b>	<p>The chimney breast has been removed in the bedroom above the dining room and as the loft has been converted I can not see how the chimney has been supported.</p>

Chimney stack supported in loft

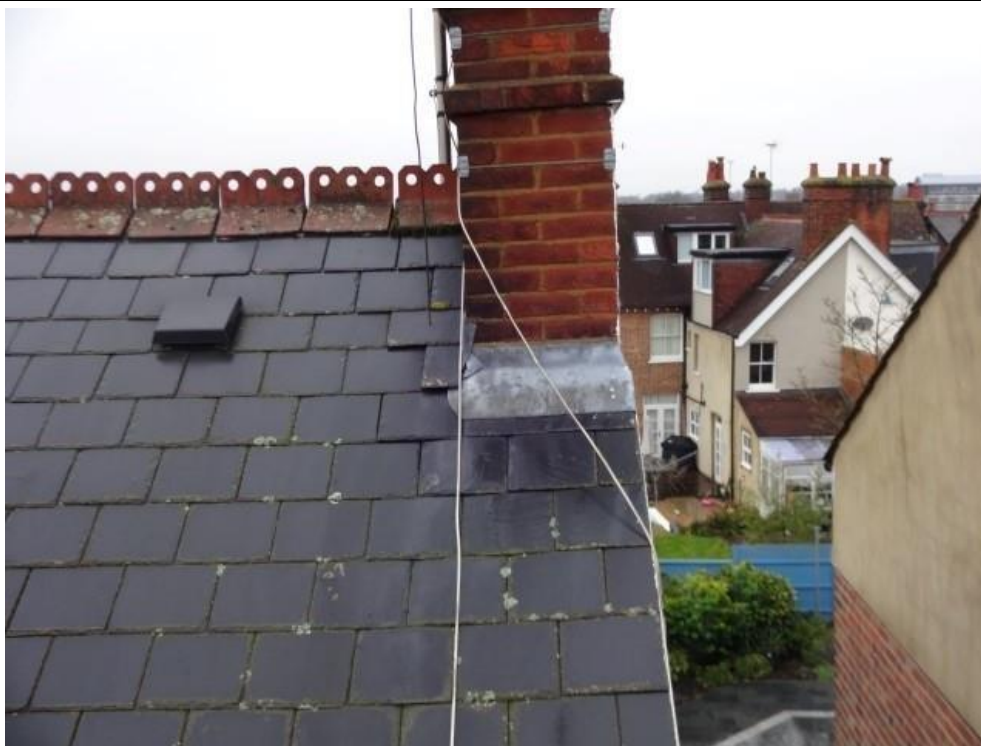
Front chimney

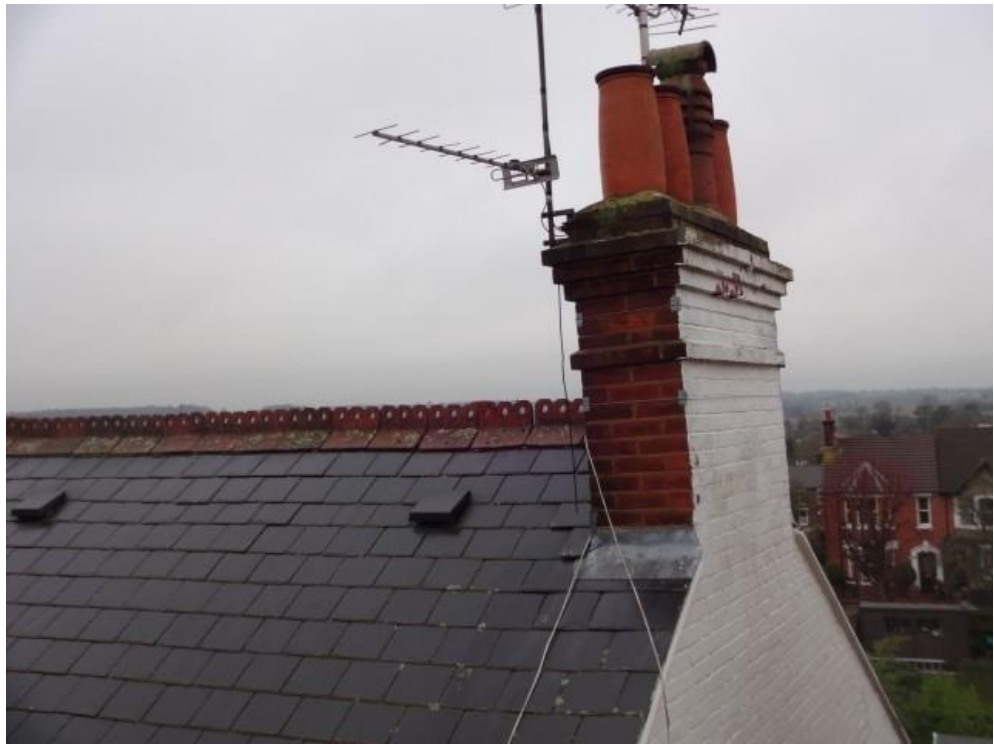
Front chimney stack

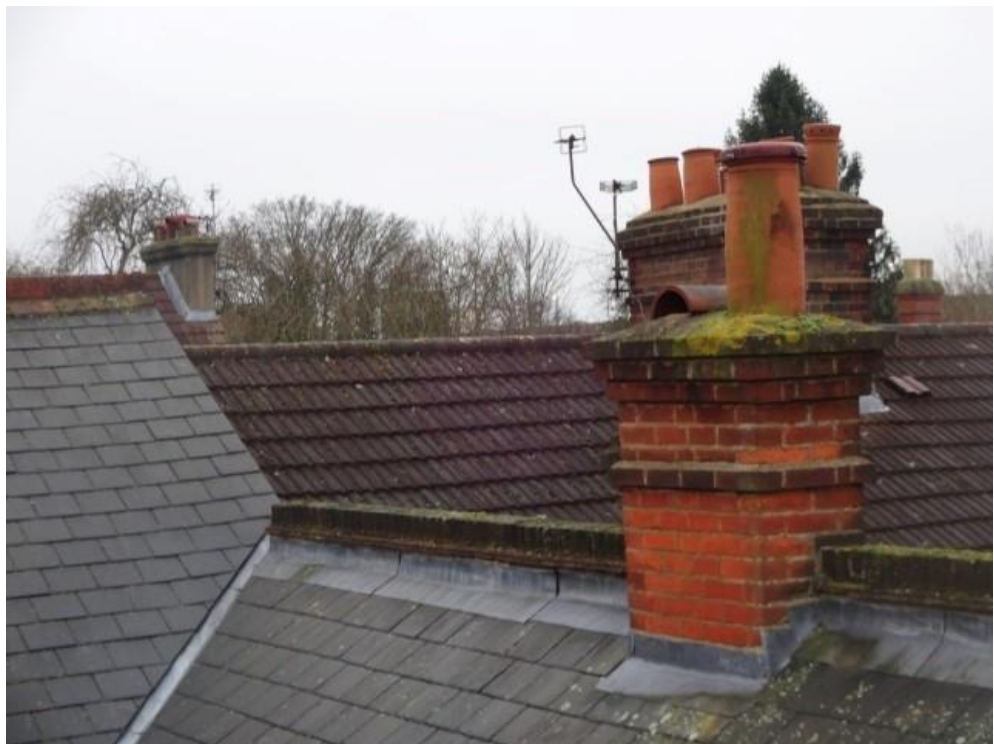
Rear redundant chimney stack

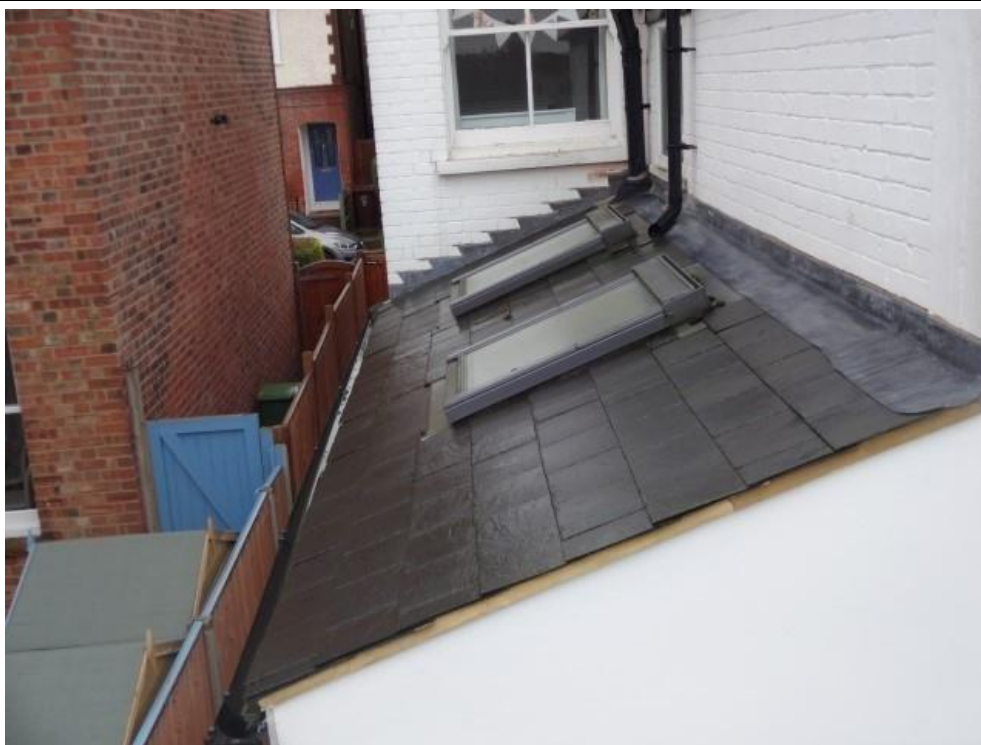
<b>4.2 Roof Coverings</b>	<b>Condition rating</b>	<b>3</b>
<b>Construction &amp; Type</b>	The main roof slopes are pitched and covered with artificial tiles. All ridge tiles are clay, the valley gutters are swept and lined with lead.		
<b>Nature of inspection and Limitations</b>	The roof pitches were examined from ground level with the aid of binoculars and using a pole camera, where necessary for possible defects including sagging, collapse, broken/missing/damaged tiles, holes, and other evidence of failure.		
<b>Condition</b>	<p><b>Pitched Sections</b></p> <p>The majority of the slates seen were in a fair condition with no evidence of any major failures or defects. The mortar at the verges (side most run of tiles) is complete and intact with no evidence of any major weathering. The top line of ridge tiles is even with no evidence of any undue levels of flexing or bowing.</p> <p>The slates to the rear round the loft velux windows have slipped and are missing these will need to be replaced.</p>

Roof over kitchen

<b>Action Required</b>	<p>Pitched Sections: Carry out normal maintenance including removal of moss build-up.</p> <p>There are slipped and missing slates round the rear velux windows to the loft conversion these need to be replaced.</p> <p>Any slipped, missing or broken slates on the roof pitches should be repaired and replaced.</p> <p>You should carry out a thorough visual inspection at least once a year, ideally in the Spring to identify and repair any damage that could have been caused by winter weather. Any missing mortar at the verges and beneath any hip or ridge tiles should be replaced. Any moss or other accumulated plant matter should be cleared</p>

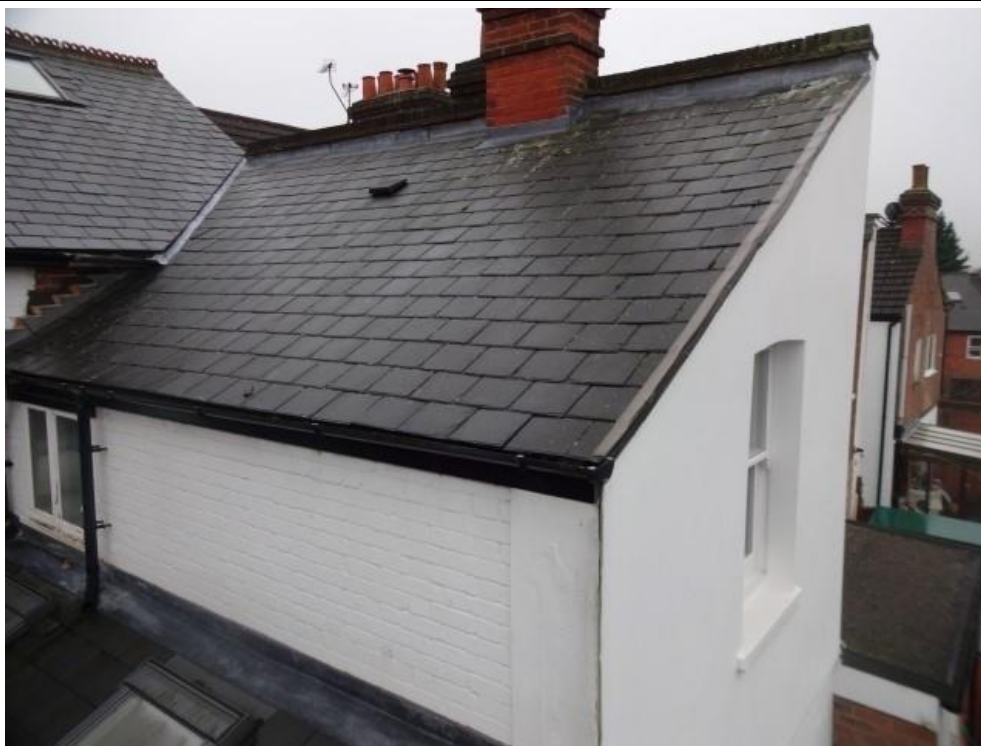
Roof over bathroom bedroom 3

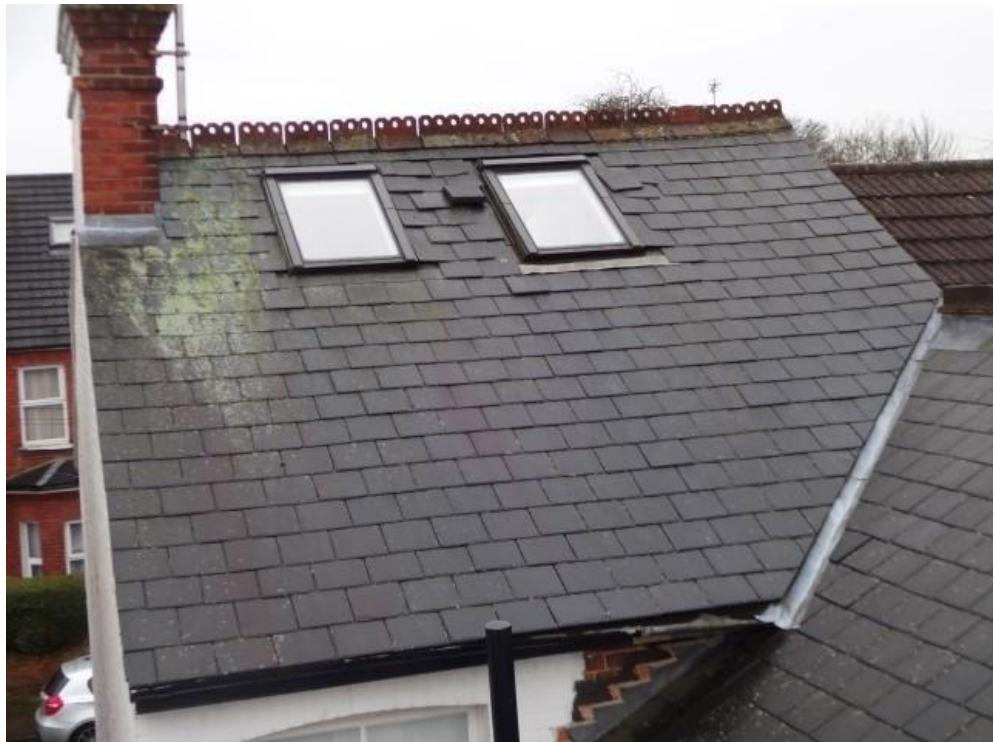
Roof over bedroom 2

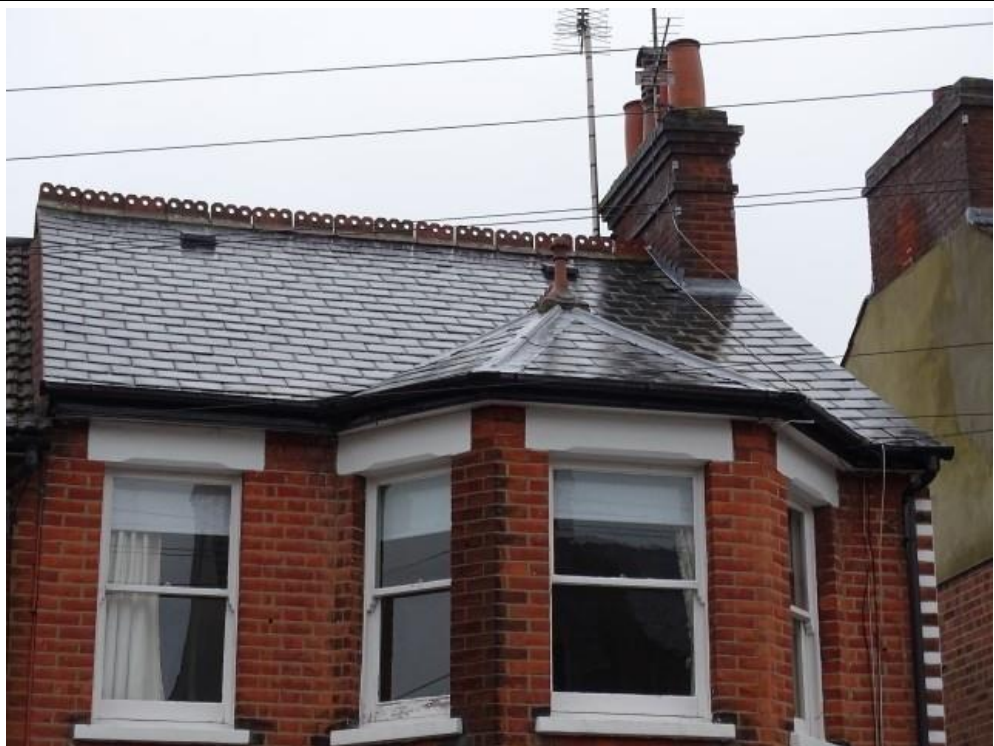
Front roof

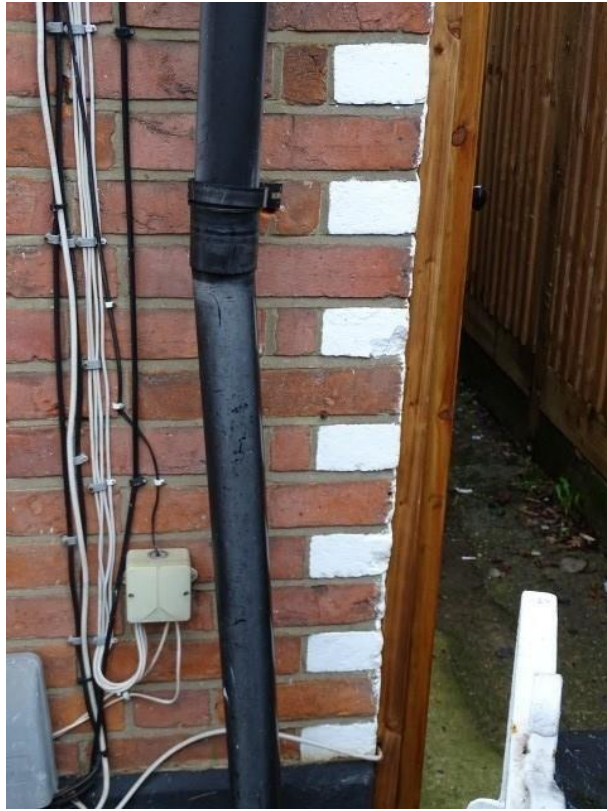
<b>Condition</b>	<p>The gutters are currently in fair condition and alignment. There were no significant leaks noted but all gutters require examining periodically and clearing of moss, leaves and silt which will inevitably accumulate.</p>		
<b>Action Required</b>	<p>Gutters and downpipes should be cleaned and inspected regularly to ensure that they are free from blockages and leaks. If it is noted during any heavy rain, that gutters or down pipe joints are leaking, then these must be fixed as soon as possible to prevent water penetration to the property and damage to the foundations.</p> <p>The front gutter down pipe needs refixing to the front wall.</p>

Front gutter down pipe

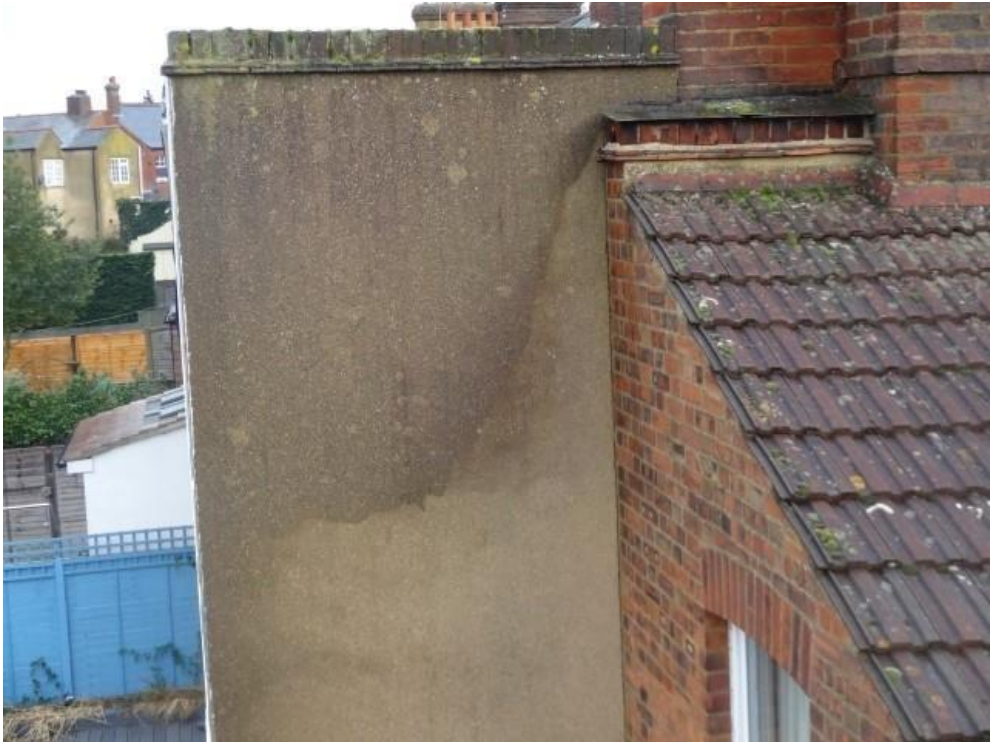
<p>Rear wall of Bedroom 3</p>

<p><b>Action Required</b></p>	<p>Walls should be examined regularly to inspect for changes in the nature of any cracking or other defects that may become apparent. The side rear wall of bedroom 3 is wet and soaking through the wall there is a crack in the render this render should be made water proof possibly by matching the render on the rear of the property.</p>

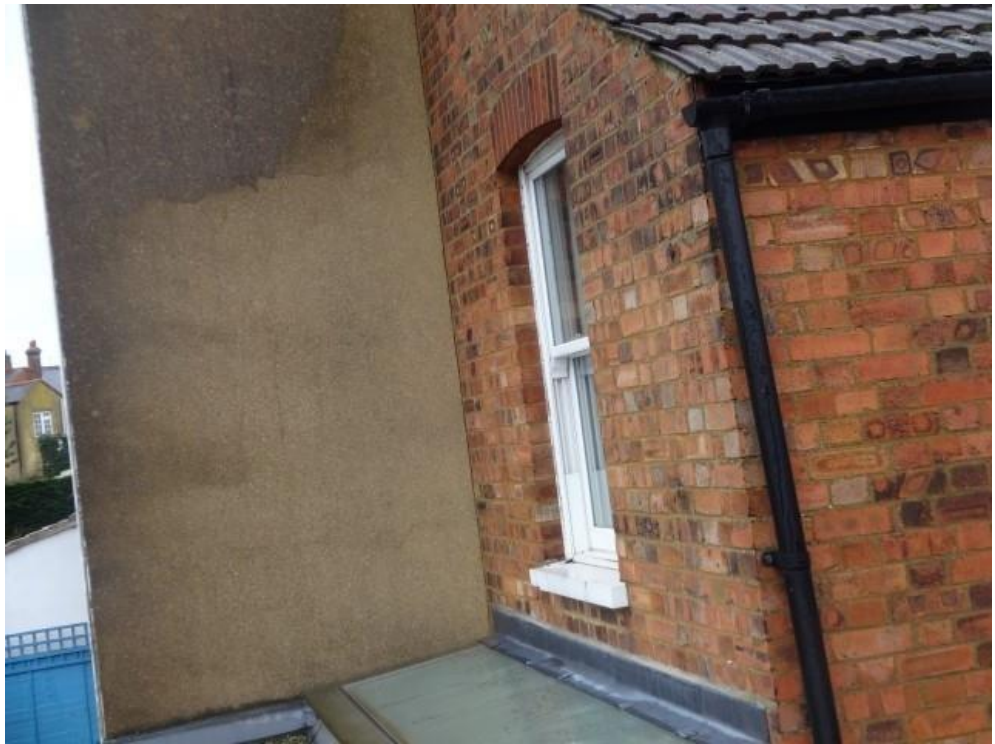
Next door in relation to rear bedroom 3 external wall

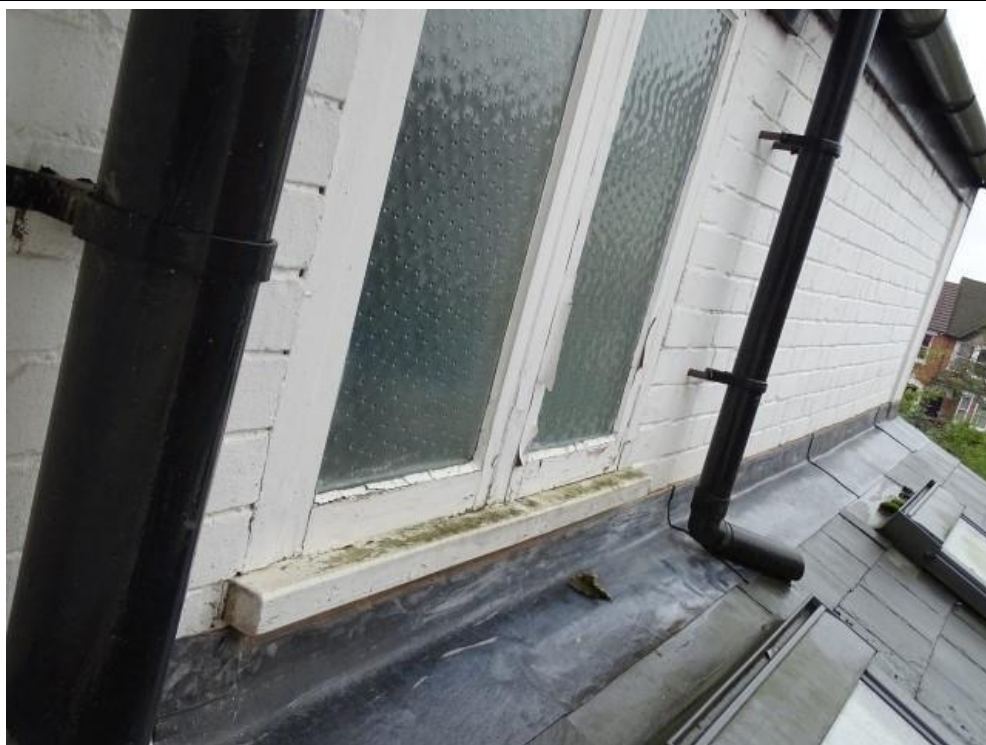
Bathroom fixed casement rotten

<b>Action Required</b>	<p>The bathroom fixed casement window is rotten and the opening casement needs easing, it would be better to replace this window. There is rot to the bottom frame of the right hand bay window in bedroom</p> <p>one. Normal maintenance of frames, hinges and locks is required.</p> <p>Be aware that previous owners may have distributed multiple sets of keys for the windows and doors to individuals not known to you. When purchasing a property, you should consider the cost of replacing all of the door and window locks as soon as possible after you take up occupation. When doing this you should consult your insurers to ensure that you meet their requirements for security, and obtain any discounts that may be available by improving the security of the property.</p>

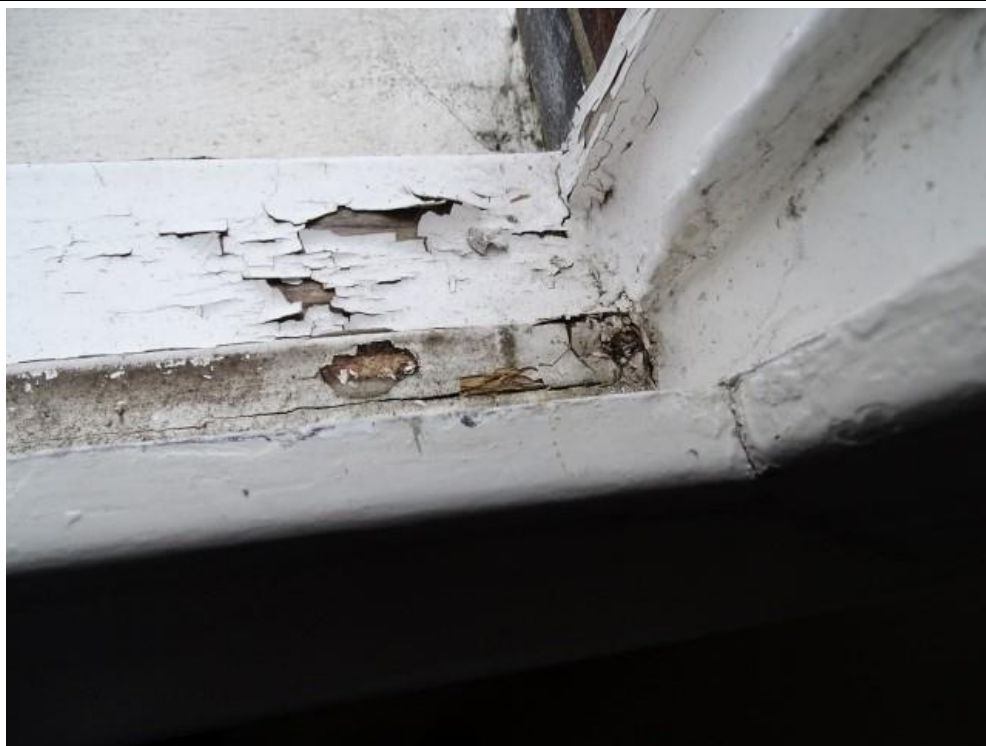
Bedroom 1 bottom sash frame rotten

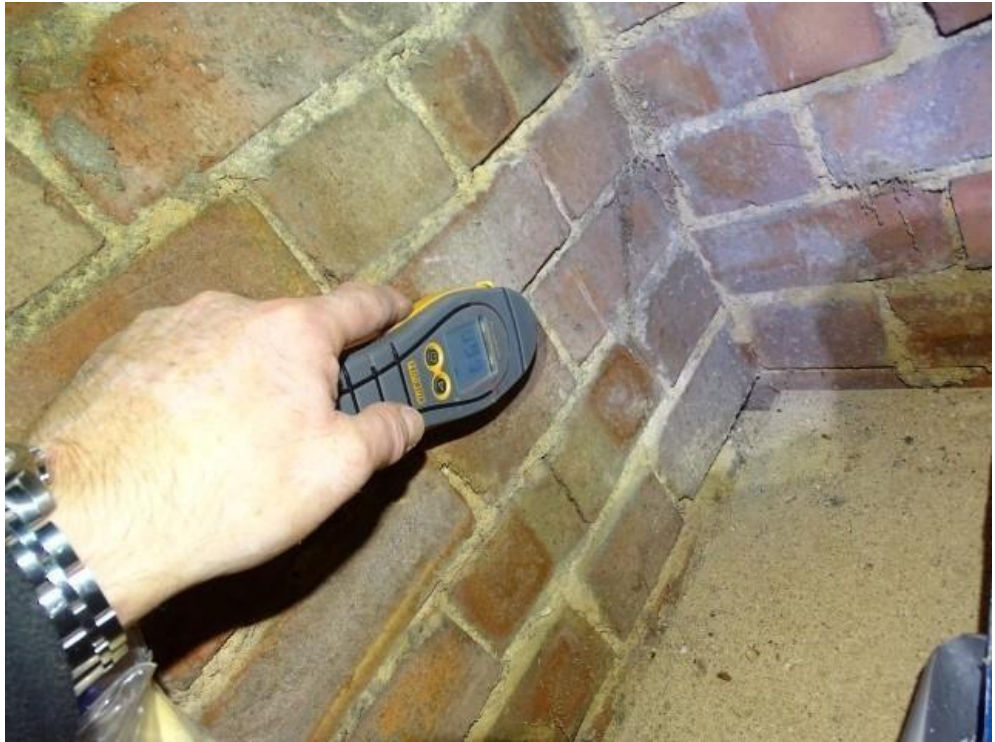
Wet wall in loft above bedroom 3

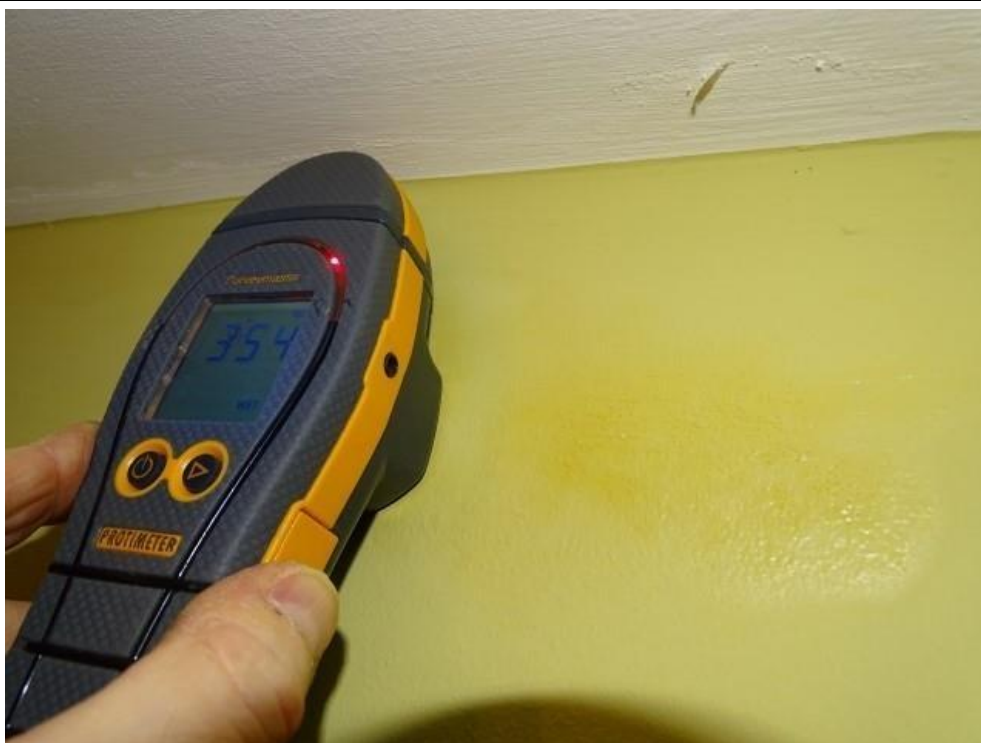
<b>5.3 Walls</b>	<b>Condition rating</b>	<b>2</b>
<b>Construction &amp; Type</b>	The internal walls are of both solid and timber stud construction.		
<b>Nature of inspection and Limitations</b>	Internal walls were examined for indications of bowing, leaning, cracking and undue surface failure/damage. Moisture meter readings were taken at regular intervals where access and wall construction/location permitted.		
<b>Condition</b>	<p>All internal walls and ceilings have been maintained and all surfaces are presented in a fair decorative order. Some general unevenness was noted. This is due to normal disturbance of the surface by decorations, minor repairs and fittings having been attached in the past.</p> <p>Dampness was recorded to the rear wall of bedroom 3 at high level in the left hand corner reading of 999 and to the left hand gable wall reading of 563 at high level.</p> <p>Dampness was found to the chimney breast of the dining room chimney breast at high level reading of 354 and to the right hand side of the chimney breast at low level 999. These need further investigation.</p>

Dining room chimney breast at high level

<b>Action Required</b>	<p>Wall Removal: As part of the legal process, your legal adviser should contact building control at the local council and obtain any records of any notifiable works completed.</p> <p>Normal maintenance is required, including filling and redecorating cracks as necessary.</p>

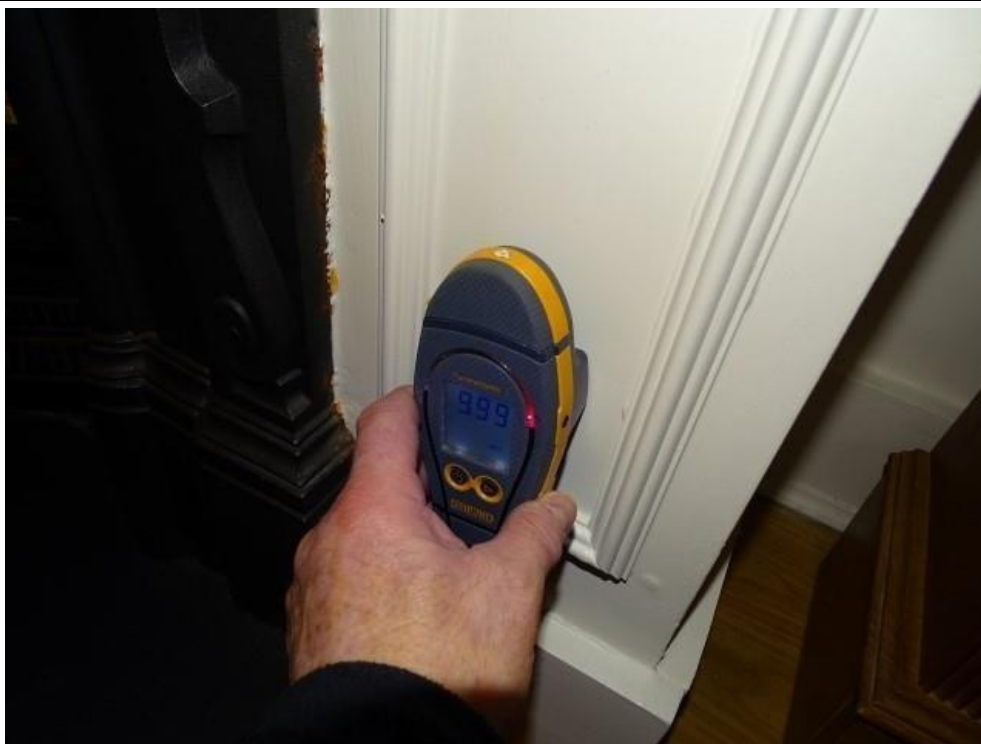
Chimney breast in dining room at low level

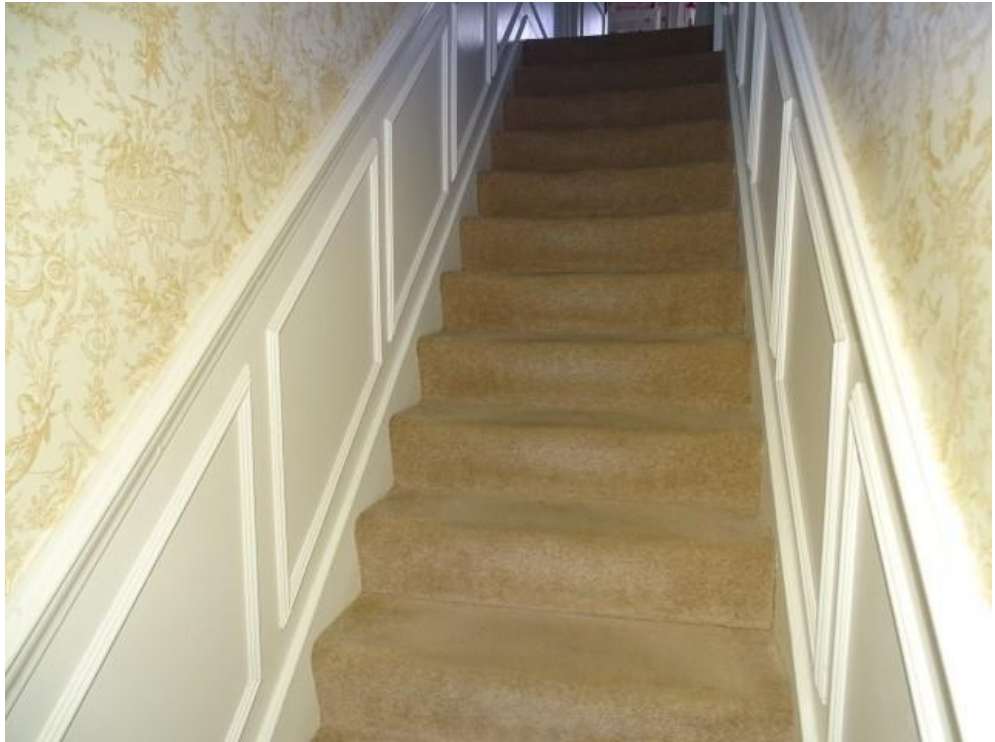
Staircase

<b>Action Required</b>	<p>Door hinges and locks should be regularly lubricated. Internal timbers should be inspected regularly for evidence of bowing or distortion, woodworm and other defects.</p> <p>Fit handrail to staircase.</p>

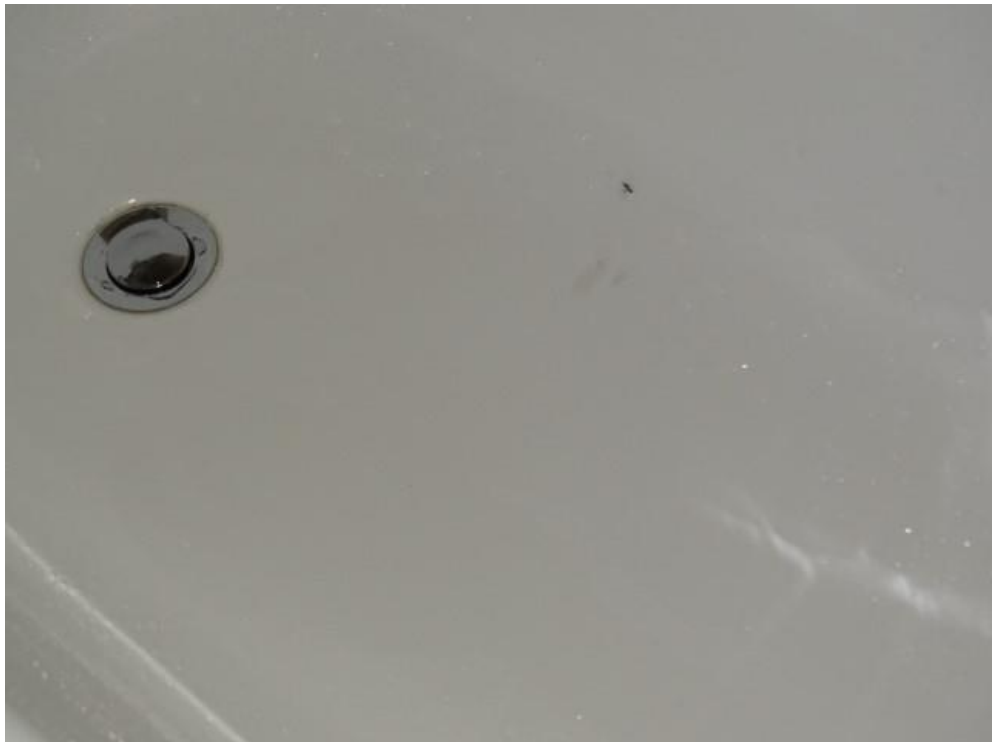
Chip in bath enamel

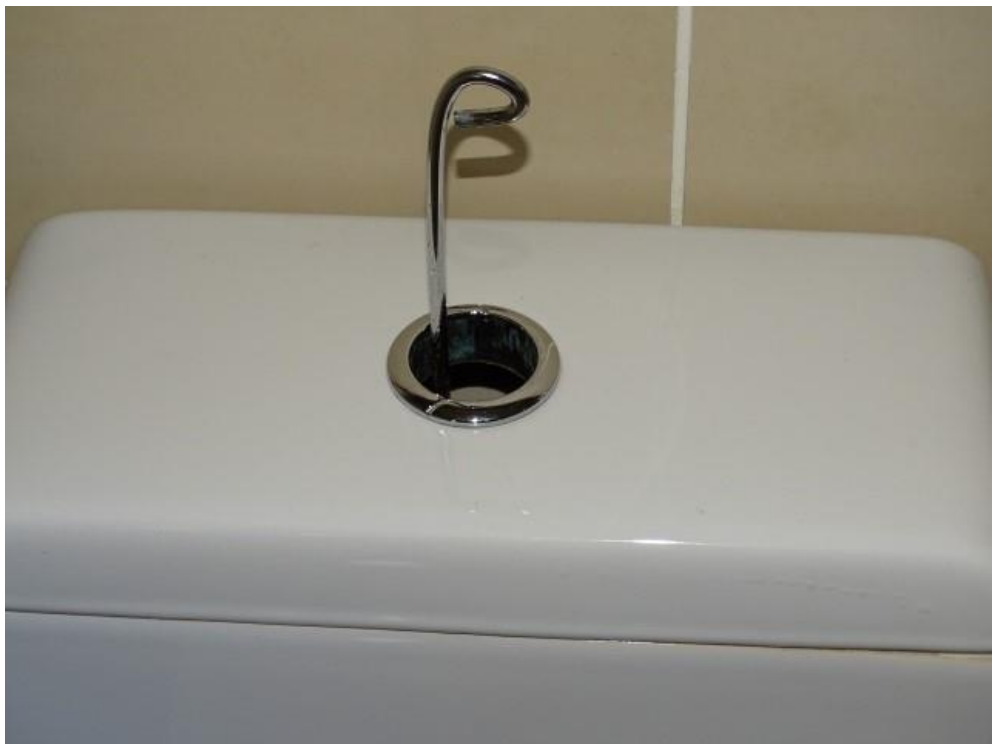
Flush mechanism button broken

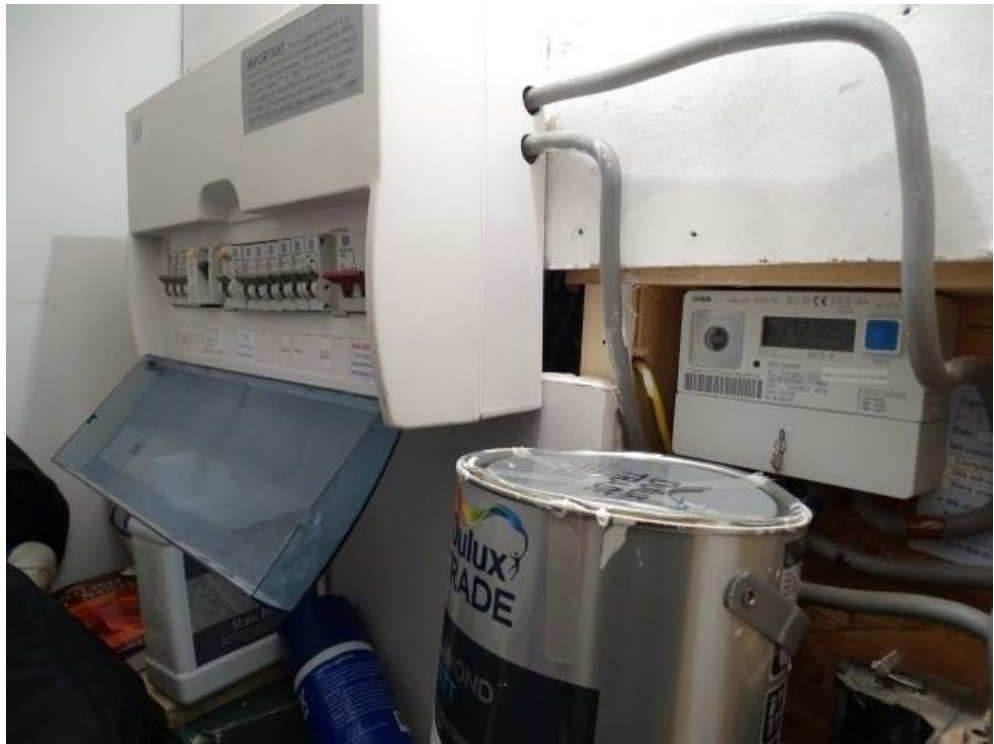
<b>Condition</b>	<p>In general the electrical circuits seen are in a fair condition. PVC cabling was observed at the property and the socket face plates and switch plates are of a suitable modern quality. However to some rooms there are an insufficient number of sockets for modern living standards, this means a level of new circuitry or rewiring may be required. There are also some specific observations listed below which require attention.</p> <p>Observed Issues Some of the down lighters in the property are loose in the ceilings</p>		
<b>Action Required</b>	<p>Some services will be obscured by furniture and other objects at the time of the survey. Upon occupation it is strongly advisable to visually check all socket outlets and switch points for any broken housings or loose fascias. Any damage seen should be repaired accordingly.</p> <p>The NICEIC recommends that electrical installations are subjected to an Electrical Installation Condition Report (EICR) by a suitably qualified engineer at least every 10 years. They further recommend that a PIR be carried</p>

Electric meter and consumer unit

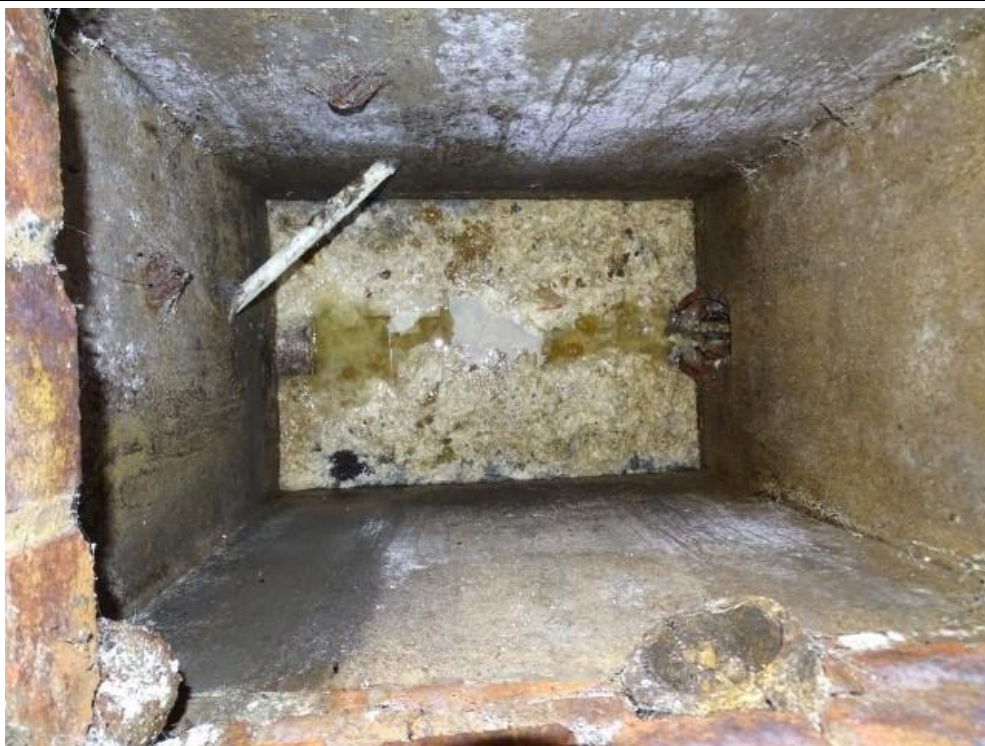
Manhole at front of property partially blocked

<b>Condition</b>	<p>Without extensive exposure work we cannot confirm the type or layout of the underground drainage system.</p>		
<b>Action Required</b>	<p>Drains should be regularly inspected to ensure they remain free from blockages, tree root damage or other obstructions.</p> <p>We would recommend that the front manhole is cleared.</p>
