# BUILDING SURVEY REPORT

SURVEY DATE 23 Jan 2018

The format of this MiBuilding Survey Report is consistent with the guidance note requirements for a Survey Level 3 as defined by RICS Surveys of Residential Property 3rd edition May 2016

### Etna Road, St. Albans

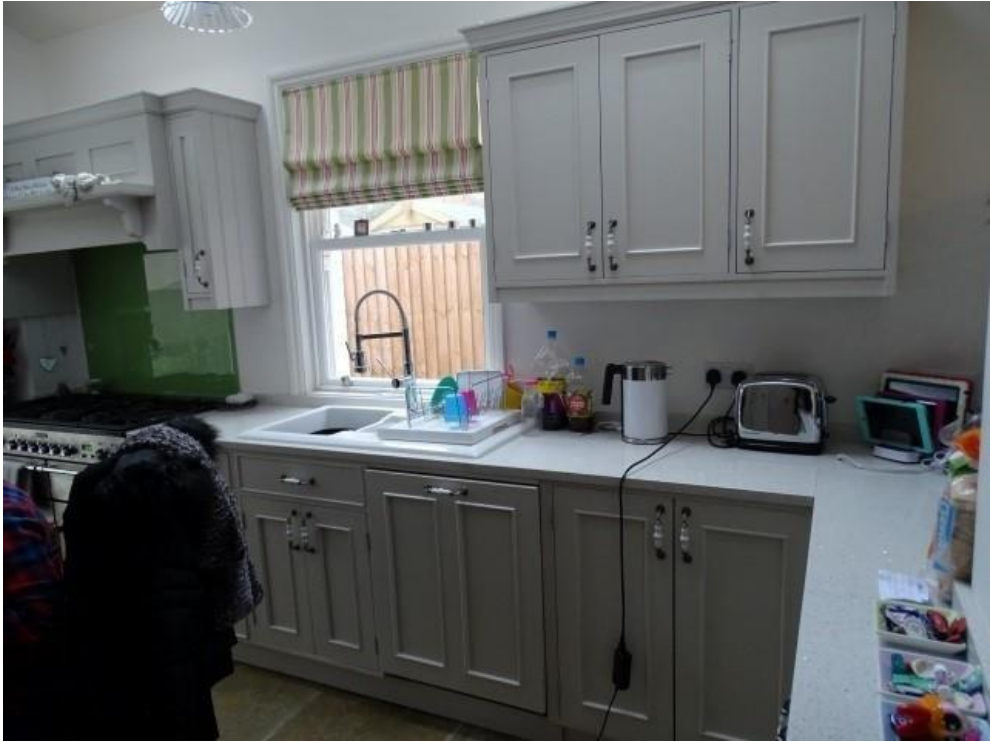
<p>DSC04150 (Small)</p> </div>

<h2 style="text-align: center;">5.6 Built-In Fittings</h2>	<p style="text-align: center;"><b>Condition rating</b></p>	<p style="margin: 0;">1</p>
<p><b>Construction &amp; Type</b></p>	<p>The kitchen fittings are modern style. The worktops are of marble, units are a mixture of wall-hung and floor standing.</p>		
<p><b>Nature of inspection and Limitations</b></p>	<p>The kitchen units and utility room were examined for general condition. A selection of cupboards and drawers were checked for normal operation. Built in appliances were not checked for operation or safety. No significant defects or damage was noted but some modernising and updating may now be required.</p> <p>Fitted wardrobes (and walk-in cupboards) were checked for general condition and door operation. Bedroom 4 wardrobe has a curtain instead of doors</p>		
<p><b>Condition</b></p>	<p>No Significant Defects are Noted.</p>		
<p><b>Action Required</b></p>	<p>Normal Maintenance is Required</p>

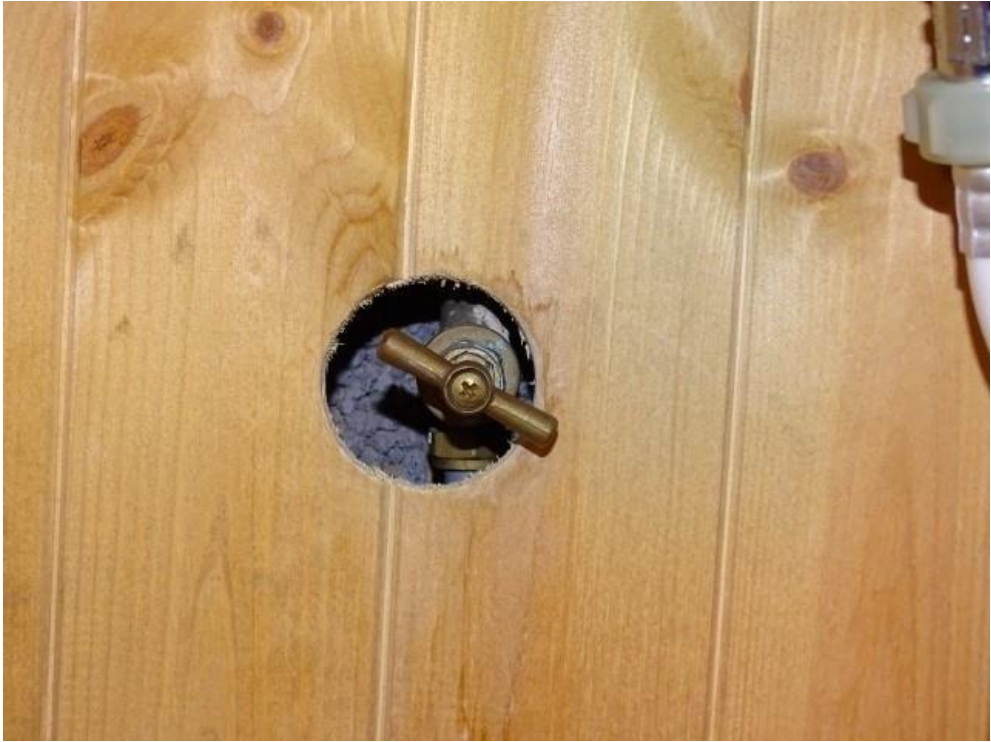
<b>6.3 Water</b>	<b>Condition rating</b>	<b>1</b>
<b>Construction &amp; Type</b>	<p>There is a mains water supply. The incoming mains pipework is copper and the stop valve is under the kitchen sink.</p> <p>The water installation is of the more modern unvented system style. This does not require a cold water storage tank; all the cold water draw-off points are fed directly off the mains supply. There are no water storage facilities (hot or cold) at the property.</p>		
<b>Nature of inspection and Limitations</b>	<p>The visible parts of the system were checked for any obvious signs of leaking, damaged pipes, correct covering and insulation, and other evidence of defects. Water taps were operated to check for flow pressure and correct drainage.</p>		
<b>Condition</b>	<p>No significant defects are noted, all fittings operated as required with water pressures at fair levels.</p>		
<b>Action Required</b>	<p>Check the installation for evidence of leaks or other defects on a regular basis i.e. approximately every 6 months, or sooner. Leaks most often occur at pipe joints and where pipes are subject to movement or physical damage, such as airing cupboards, roof spaces and under sinks.</p>

</div> <p style="text-align: center;">Main stopcock under sink</p>

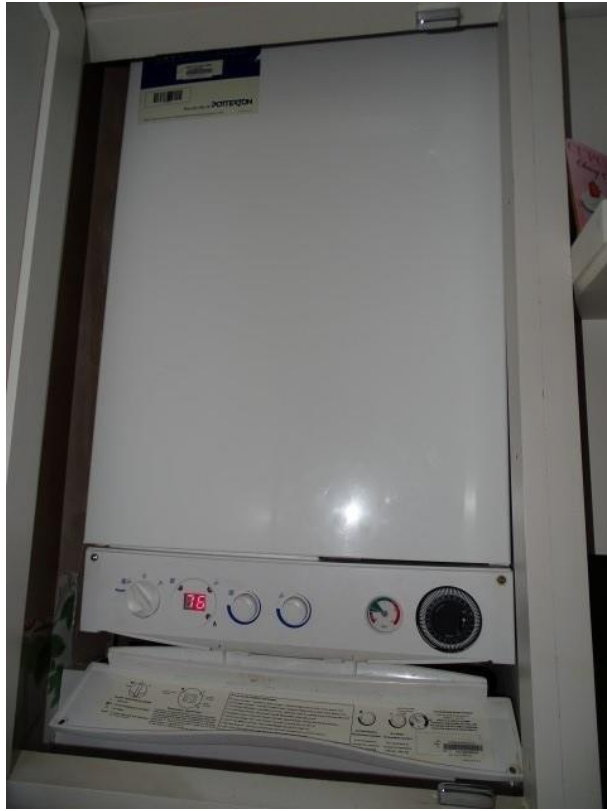
Boiler

<b>Nature of inspection and Limitations</b>	<p>It is not possible to fully assess the condition and safety of a gas and heating installation on the basis of a visual inspection only. A visual inspection was carried out of the radiators, pipework and boiler to detect leaks, corrosion and other common defects.</p>		
<b>Condition</b>	<p>COMBI - The radiator system was not in operation during the survey but the hot taps were tested, the boiler fired and hot water was delivered. The water pressure in the radiator circuit is at 1. bar which is as required.</p> <p>No visible repairs were noted but we would recommend seeing the boiler and radiator system in full operation with radiators becoming warm to the top and bottom. The hot water system should also be tested.</p> <p>T Note: Combination boilers can only provide hot water to one appliance at a time (usually the appliance closest to the boiler.) Consequently if there is more than one demand for the boiler at a time the appliances further away can get reduced levels of hot water. It can also take longer to fill a bath than with a traditional system.</p>

<b>Action Required</b>	<p>No visible repairs were noted; normal maintenance servicing must be continually undertaken.</p> <p>Health and Safety – See also notes in 6.2 regarding the general safety and servicing of the complete Gas system.</p>

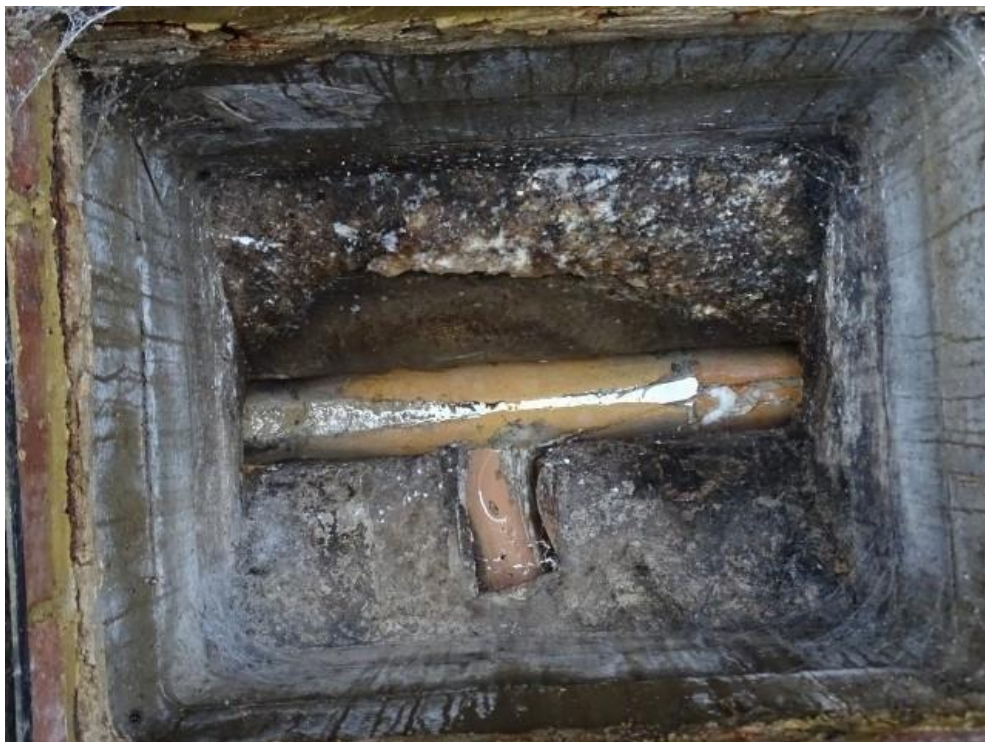
Manhole down alley way

<b>6.5 Drainage</b>	<b>Condition rating</b>	<b>2</b>
<b>Construction &amp; Type</b>	<p>There is a mains underground drainage system.</p> <p>There was two inspection chambers located to the side of the property. The chamber had a galvanised steel cover, brick rendered chamber walls and salt glazed pipes at the chamber entrance.</p>		
<b>Nature of inspection and Limitations</b>	<p>The drains run down the side of the property and to the main road at the front.</p> <p>Both covers were lifted, all taps were run and WC's flushed There seems to be a partial blockage where the sewage gets to the front manhole</p> <p>Internally, all taps were run and WC's flushed, and water was seen to be running clear from the internal services.</p> <p>It should be noted that the underground drainage network was not inspected with the use of cameras and therefore no assessment could be made of the condition of the drains other than at the inspection chambers described above.</p>

<b>Condition</b>	<p>Without extensive exposure work we cannot confirm the type or layout of the underground drainage system.</p>		
<b>Action Required</b>	<p>Drains should be regularly inspected to ensure they remain free from blockages, tree root damage or other obstructions.</p> <p>We would recommend that the front manhole is cleared.</p>

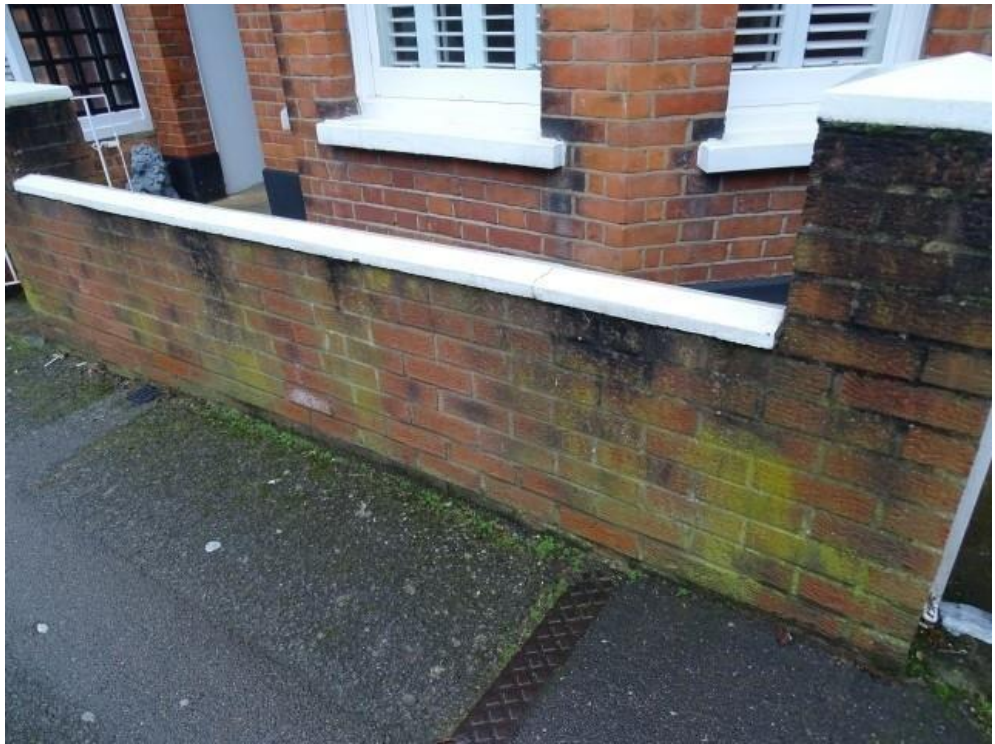
Front wall

<b>Condition</b>	<p>There is no evidence of any damage from flooding.</p> <p>The gardens are both presented in a fair and highly maintained condition.</p> <p>The fencing is also presented in a fair condition.</p> <p>The side concrete path is in a poor condition.</p> <p>The front wall has a small crack in it this should be watched to see if it gets worse over time.</p>		
<b>Action Required</b>	<p>Normal Maintenance is Required.</p>
